MARINE INVESTIGATION REPORT
M01M0005

FIRE - STARBOARD ENGINE ROOM

THEBAUD SEA

**OFFSHORE PLATFORM SUPPLY &
DIVING SUPPORT VESSEL**

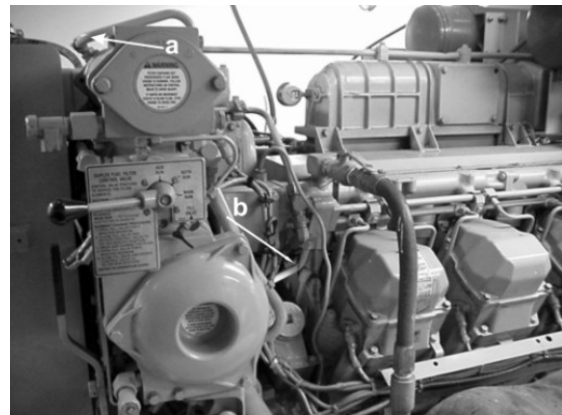
The No. 4 main generator was examined by the Transportation Safety Board of Canada (TSB) on the morning of 04 February 2001. The primary fuel oil filter housing runs the width of the generator and is located just forward of the generator and aft of the freshwater header tank. The secondary fuel oil filter housing runs half the breadth of the generator and is located directly above the primary fuel oil filter housing on the inboard side of the generator. The fuel oil selector cock was found to be in the "MAIN RUN" position, indicating the primary fuel oil filter was in use at the time of the occurrence. Directly aft of the primary and secondary fuel oil housings are the cylinder heads, a charge air after-cooler and the metal shielded exhaust manifolds. The two exhaust manifolds, with temperatures of about 1150° F (620° C), are within 60 cm of the failed fuel fitting/connection.

Photo 2. Typical generator
a - Intact fuel fitting/connection
b - Exhaust manifold/potential source of ignition

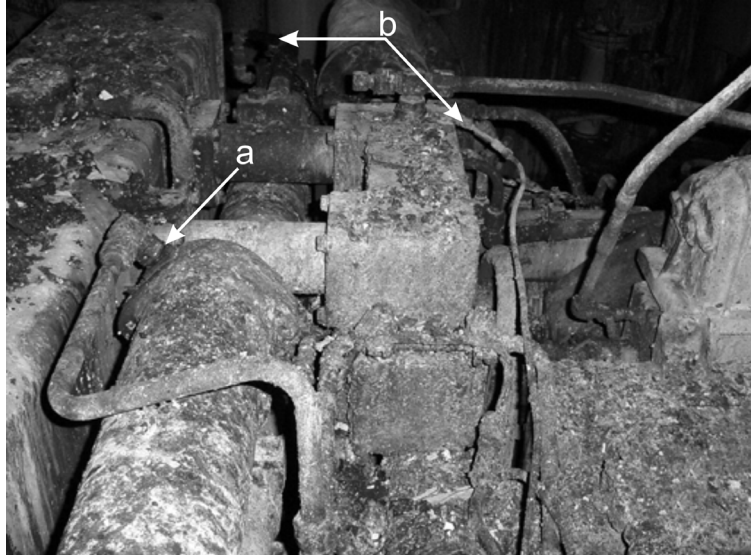
Photo 3. Possible fuel sources

- a - Damaged fuel fitting/connection (primary source of fuel)
- b - Damaged fuel hose (secondary source of fuel)

The partial separation of the fuel fitting from the filter housing in conjunction with a fuel pressure of 4.0 bar would produce a readily ignitable atomized spray. Following the occurrence, when the fuel oil system had been pressurized, the O-ring elbow of the failed fitting started to spray fuel oil at 1.5 bar, i.e., some 37.5 per cent of the normal fuel oil pressure. Given the position of the exhaust manifolds, the fuel oil released from the failed fitting/connection on the secondary fuel oil filter housing is considered to be the primary source of fuel for starting the fire.

Once the fire was established, a flexible fuel hose, which connected a composite signal line from the primary fuel oil filter to the low fuel oil pressure switch, burned through and failed. This resulted in a secondary source of fuel to feed and maintain the fire.

The fuel oil pressure alarm switches were relocated to eliminate the requirement of running a pressurized fuel oil line in the vicinity of the exhaust manifold.

Splash guards were fitted to the fuel oil filters to redirect any potential fuel leaks to the bilge.

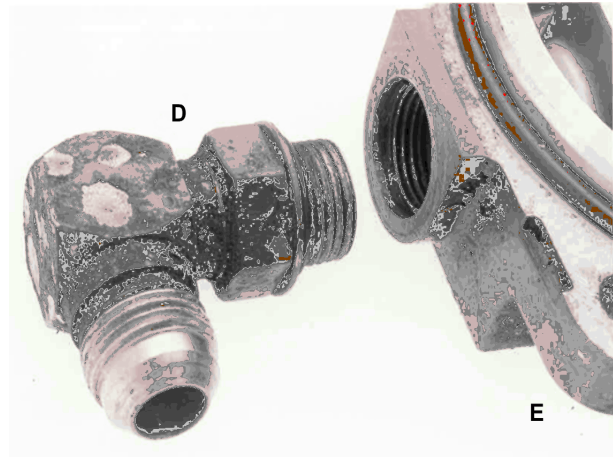
Inspection of the secondary fuel oil filter revealed a partial separation of the fuel oil outlet elbow from the end cover assembly. The separation was such that an O-ring, normally captured within the fuel oil filter end cover and completely hidden from view, was clearly visible. When the secondary fuel assembly was removed from the generator, extensive thread damage was noted on both the elbow and end cover assembly connections.

- Separation of the 90° elbow connection resulted from extensive wear of the mating threads of the elbow and the internal threads of the fuel filter end bell fitting, probably initiated by a loss of torque or backing off of the jam nut assembly. The original looseness in the connection, provided by the combination of straight threads on the connector and slightly tapered threads in the end bell fitting, would have facilitated the relative motion of the threads driven by the normally imposed generator vibrations. Leakage past the degenerated threads of the connection would appear to have provided the source of fuel for the fire.

Photo 4. Note extensive thread damage on the 90° elbow connector (D) and the secondary fuel oil filter end bell (E)

A complete inspection of all fuel fittings and connections similar to the one that failed was carried out on the five remaining generators onboard the *Thebaud Sea*. No additional problems were detected with any of the other fittings and/or connections.

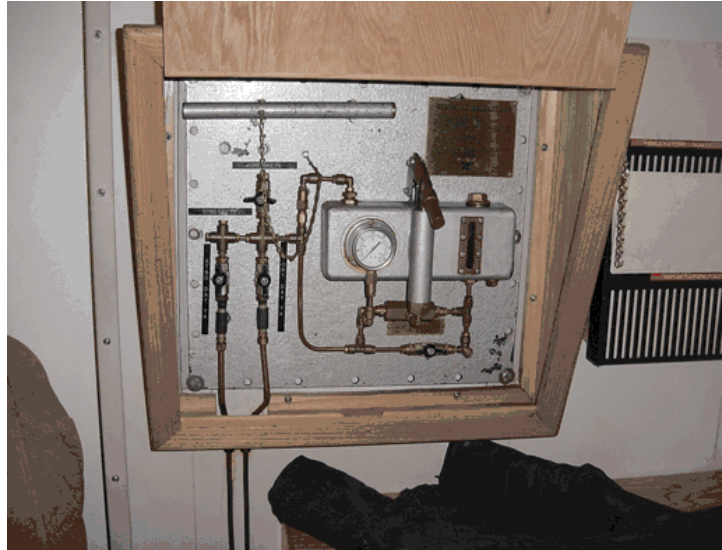
Photo 5. Fuel oil shut-off station

Prior to re-establishing main and auxiliary power onboard the vessel, an inspection of the quick-closing fuel valves by the chief engineer revealed that valves to both engine rooms were in the tripped position. This resulted in fuel starvation for all machinery in the port and starboard engine rooms and the subsequent blackout. The blackout occurred at the time the starboard engine room fuel trip had been activated. This would suggest that accidental activation of the port engine room fuel trip occurred around this time and would account for the blackout.
